# CALIFORNIA DIVISION OF MINES AND GEOLOGY FAULT EVALUATION REPORT FER-219 SUPPLEMENT No. 1

# OAK RIDGE AND RELATED FAULTS VICINITY OF FILLMORE AND SANTA PAULA Ventura County, California

by Jerome A. Treiman August 20, 1998

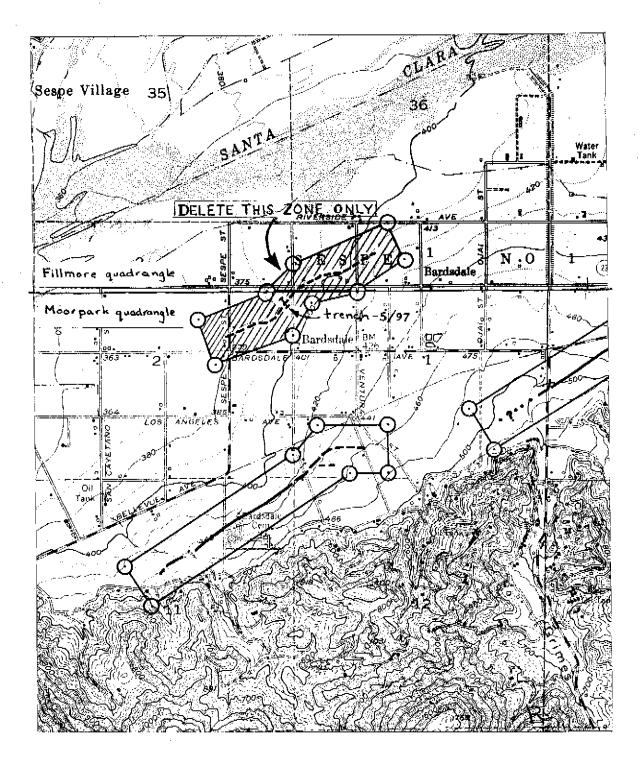
Among the features zoned in 1991 was a one kilometer long, slightly sinuous, 1.5m-high scarp-like feature that crossed the Moorpark-Fillmore quadrangle boundary in the community of Bardsdale (Figure 1). The scarp is about one kilometer north of, and parallel to, an alignment of similar discontinuous scarps. The scarp to the south had been previously investigated and found to be associated with Holocene faulting (Yeats and others, 1986). The more northerly scarp was identified in aerial photographs and in the field. It was noted at the time that it might be related to a more obvious erosional escarpment about 2km to the east, but due to a slightly different orientation and location near a previously inferred fault trace it was decided to include the fault within a new Earthquake Fault Zone (Treiman, 1990).

Research trenching in May 1997, under the direction of Dr. James Dolan (University of Southern California), across the northern scarp demonstrated that the surface topographic feature was the product of lateral stream erosion. Fluvial deposits were unfaulted and undeformed. A channel of well-bedded sand coincided with the topographic scarp. The trench is located on Figure 1.

Figure 1 (FER-219, supplement) - a portion of the Official Earthquake Fault Zone Maps for the Fillmore and Moorpark quadrangles (CDMG, 1991a,b) showing the fault zone recommended for deletion.

The short (~1km) Earthquake Fault Zone on the Moorpark and Fillmore quadrangles (as indicated on Figure 1) should be deleted from the Official Zone Maps (CDMG, 1997a,b) when these maps are otherwise revised. Pending such revisions, the indicated zone should be considered to be no longer in effect.
